WONGALING CORRIDORS FAUNA CROSSINGS

***Prepared for
Terrain NRM***

CHENOWETH
ENVIRONMENTAL PLANNING
& LANDSCAPE ARCHITECTURE

Level 20, 344 Queen Street
BRISBANE, 4000 Australia
Telephone: +61 (07) 3831 8582
Facsimile: +61 (07) 3831 8587
E-mail: mail@chenoweth.com.au
088036 September 2008

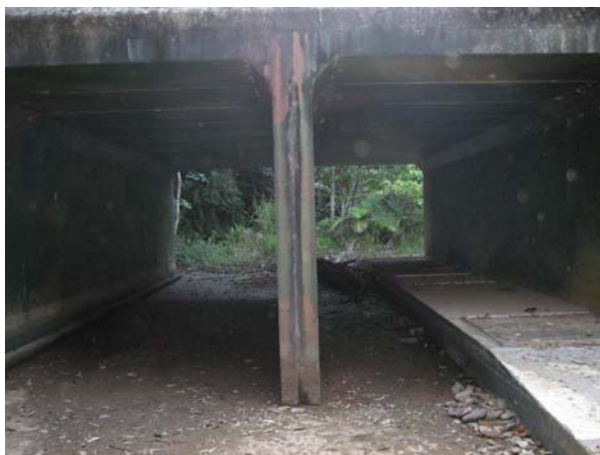
- Stoney Creek - modified culvert underpass. An existing 3m x 3m culvert was fitted with a concrete bench incorporating alternating rubber matting and sandtraps set into the bench. Fencing was installed to direct fauna towards the culvert (see Plate 1);
- North Hull Bridge - an existing bridge where approaching slopes were profiled and revegetation with cassowary food species was undertaken on approaches and under the bridge (Plate 2); and
- Limbo Creek - an unmodified large culvert representing the control site (Yates, 2008).

PLATE 1 – QDMR's large culvert trial. Note the raised platform allowing dry passage

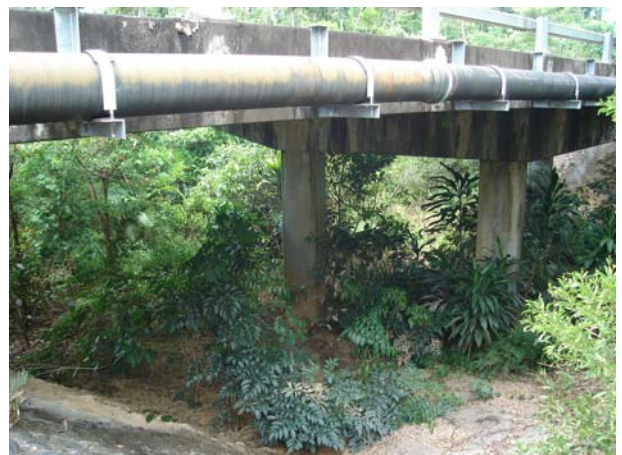
PLATE 2 – The North Hull River bridge

Although the QDMR are yet to receive a report from the Queensland Parks and Wildlife Service, initial evidence suggests that the North Hull River bridge has been utilised by Cassowaries in addition to a diversity of other fauna including snakes, bandicoots, lace monitors, pademelons, melomys, water rats, curlews, echidna and

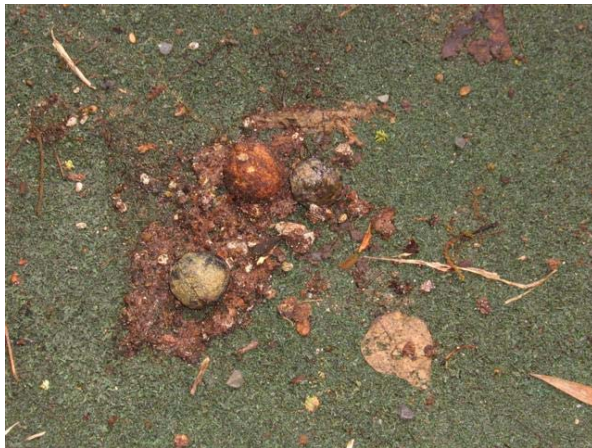
orange footed scrubfowl. Cassowary scats had been recorded in the Stoney Creek modified culvert underpass (see Plate 3), but there has been insufficient evidence to conclude they actually move through the culvert (*pers comm.*, Moore, 2008). There has however been other fauna using the culvert demonstrating that it is effective for some mammal species (*pers comm.*, Goosem, 2008). To date, there has been no evidence to suggest that the underpasses are consistently effective for cassowaries and recent tracking suggests otherwise (*pers comm.*, Goosem, 2008).

PLATE 3 – Cassowary scats in the Stoney Creek culvert (photo courtesy of the Department of Main Roads). Note the Wetpour safety surface material used to line the culvert floor.

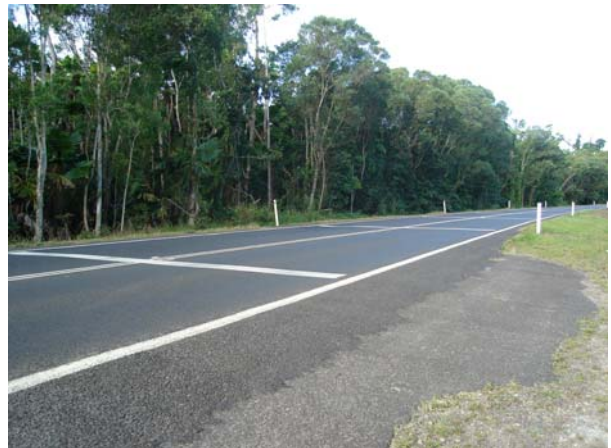
Line marking identified in Group 3 and in 4b of the measures identified in QDMR (2001) are illustrated in Plate 4.

PLATE 4 – Line markings preceding the North Hull River bridge

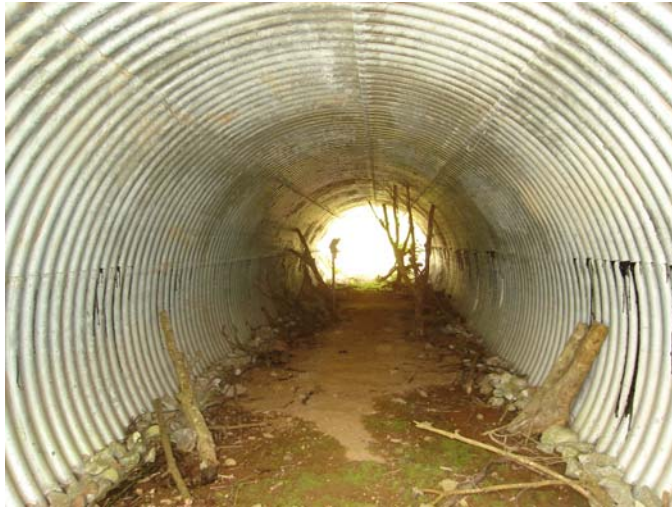
PLATE 5 – East Evelyn Road fauna underpass (photographed late 2007).

The underpasses were subsequently monitored using sand track beds complemented by infrared-triggered digital photography.

Although used by a diversity of fauna (including Lumholtz's tree-kangaroo), the Southern Cassowary has yet to use an underpass, having become exceedingly rare in the area. On one occasion a bird was observed attempting to climb through fencing erected at an underpass entrance aimed at deterring cattle from resting in the tunnel (Goosem, Weston & Bushnell, 2005), but it is not known whether the individual was or was not interested in using the underpass (*pers comm.*, Goosem, 2008). Moore (*pers comm.*, 2008), who undertook fauna assessments for the Evelyn Road upgrades, noted that cassowaries had no real reason to utilise these culverts and the length of the culvert under the road would discourage cassowary usage.

A second example is the use of timber as ‘furniture’ in the East Evelyn Road fauna underpass. Much of the timber was decomposing (see Plate 17) as a consequence of insect and fungal attack. For future work, it maybe appropriate to consider more resilient furniture, or that the periodic replacement of furniture has to be factored into a maintenance schedule.

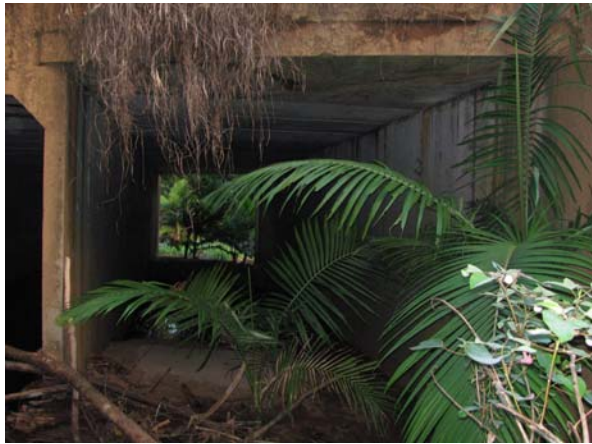
PLATE 6 – El-Arish Mission Beach Road culvert at Lacey Creek.

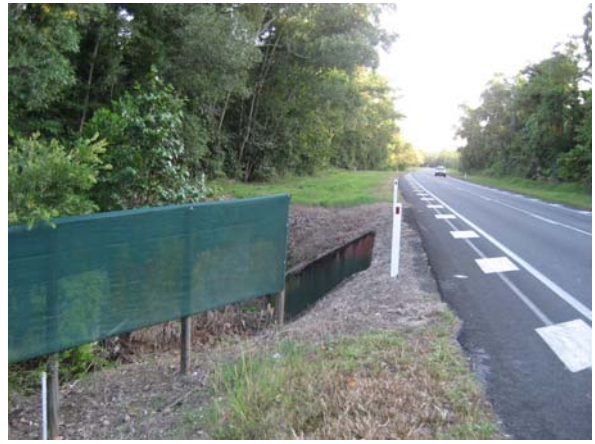
PLATE 7 – Guide fencing at Stoney Creek. Also note diagonal bars at road edge.

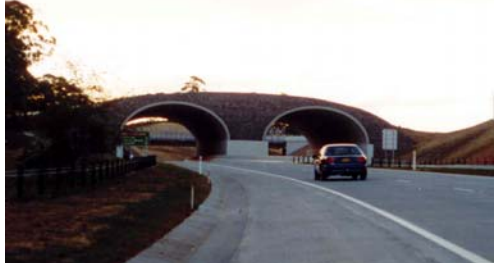
<p>PLATE 8 - Fauna Overpass – Yelgun to Chinderah Freeway (NSW)</p>

<p>fencing is vital to their functionality.</p> <p>Veage & Jones (2007) recorded swift use of the Compton Road land bridge by three species of macropod following construction. Interestingly, the authors attribute this rapid use to the presence of favourable grazing opportunities on the bridge thereby resulting in acclimatization.</p>	
Overpass (small roads)	This bridge above the major linear infrastructure is typically to allow human access across the road. This overpass is typically narrow and not hourglass shaped. The road on the overpass is typically a minor road - it may be unsealed, single lane etc.	-	-	-
Canopy bridge	This is a rope or pole suspended above the traffic, either from vertical poles or from trees. Typically installed for arboreal and scansorial species.	<p>Squirrel glider, Fawn footed melomys, possums (Common brushtail, Common ringtail, Coppery brushtail, Eastern pygmy, Green ringtail, Herbert River Ringtail, Lemuroid ringtail, Long-tailed pygmy and striped)</p>	-

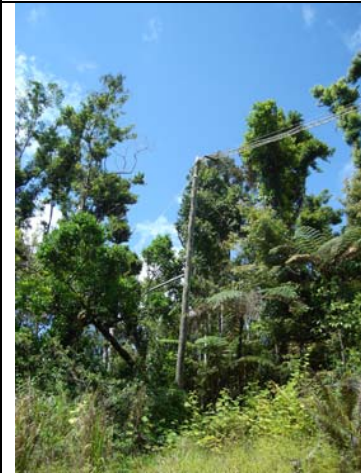
<p>PLATE 9 - Canopy bridge installed over the Palmerston Highway (Queensland)</p>

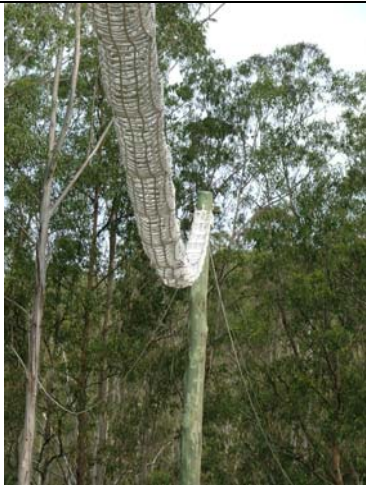
<p>PLATE 10 - Canopy bridge installed over the Summerland Way (NSW)</p>
Glider pole	These are vertical poles placed in the centre median or on the road verge, and provide species that glide intermediate landing and launch opportunities.	-	Work being undertaken on the Compton Road structures (Veage & Jones) is at this stage inconclusive. However, gliders have been recorded on the poles through hair tube analysis.

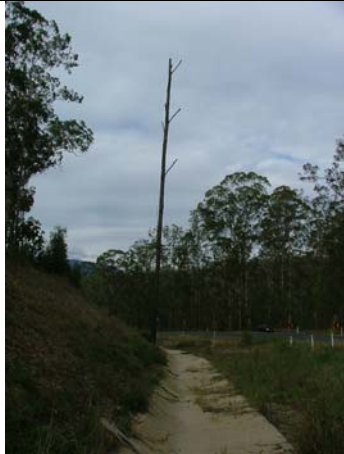
<p>PLATE 11 - Glider pole installed on the Summerland Way (NSW)</p>

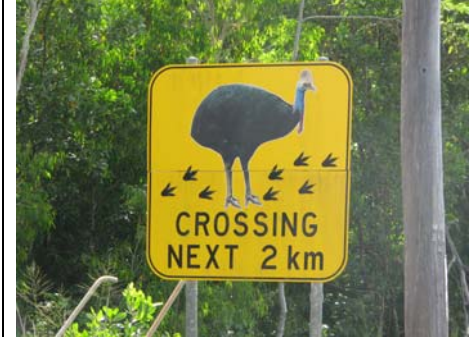
<p>PLATE 12 – Signage installed as a result of the Cassowary Management Strategy - Tully Mission Beach Road.</p>
Underpass (Allows the passage of animals below the major linear infrastructure)				
Culvert	Culverts are typically square, rectangular or half-circle in shape and may be purpose built for fauna passage or water drainage, or a combination of both. They are typically pre-cast concrete cells or arches made of steel (Figs 4 - 6). By definition, culverts were originally used to carry water. However, engineers and road designers are familiar with the size and shape of culverts, and hence we suggest the continued use of the term 'culvert' to describe this type of underpass.	Frogs, birds (at least 4 species including brush turkey), antechinus, bandicoots (Long nosed, Northern brown), Rufus bettong, Dunnart, Echidna, Sugar glider, Koala, macropods (Eastern grey kangaroo, wallabies), rats, possums (Common ringtail, Coppery brushtail and Eastern pygmy), Long nosed potoroo, Spotted-tailed quoll, Lumholtz's tree-kangaroo, wombat, several lizard and snake species.	<p>For some time culverts have been utilised in North America to facilitate the movement of large game species such as elk, deer and mountain goats under highways (DMR, 2000). Similarly, in Australia fauna have been recorded utilising culverts for movement. In recognition of their value, research has been undertaken into identifying the attributes of culverts that make them favourable to faunal movement and 'furniture' has been installed in standard culverts to enhance their function as faunal passages.</p> <p>The exact dimensions of underpass structures is complicated and dictated by many variables. As a general 'rule of thumb' bridges offer the best passage for fauna, however if culverts or dedicated fauna tunnels have to be used due to other considerations, then wide short passages are preferred to cater for the greatest diversity of species (CEPLA, 2003). The use of 'furniture'</p>

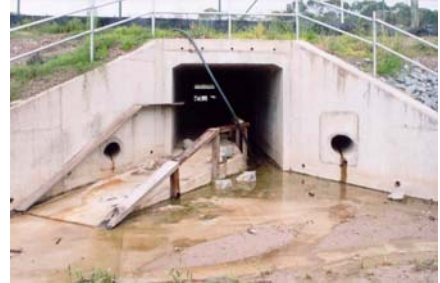
such as rocks, ropes and ledges and appropriate planting at entrances have been shown to facilitate the movement of some species (CEPLA, 2003). It is vital that dry passage is provided for terrestrial species.

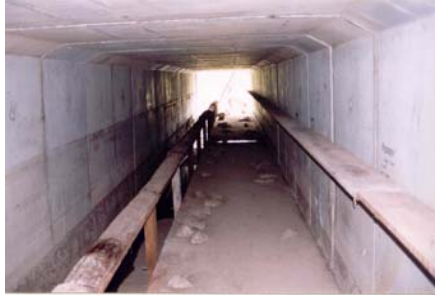
<p>PLATE 13 - Dedicated fauna culvert with furniture, Compton Road, Brisbane.</p>
Tunnel	Tunnels are typically round pipes of relatively small diameter (e.g. < 1.5 metres diameter). May also be termed "eco-pipe".	Birds, southern bandicoot, lizards.	-	-
Bridge	A bridge is a structure that maintains the grade of the road or elevates the traffic above the surrounding land, allowing animals the opportunity to pass under the road. When used to mitigate the barrier effect of linear infrastructure, the primary function is often to facilitate water drainage or the movement of local human traffic, and secondarily to facilitate the passage of wildlife.	Numerous frog species, numerous bird species, numerous bat species, echidna, gliders, macropods (Eastern grey kangaroo, wallabies), Koala, possums, Platypus, rats, numerous reptile species	Raised bridges are guaranteed to enable the cassowaries past the road safely (<i>pers comm.</i> , Moore, 2008). They are known to be used by cassowaries (<i>pers comm.</i> , Moore, 2008) and have been recommended by WTMA for the Wet Tropics (see Section 3.1.2).

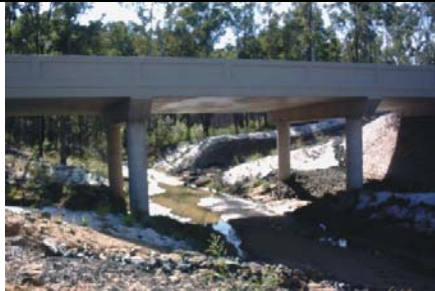
<p>PLATE 14 - Bridge designed to cater for fauna movement, Springfield, Ipswich.</p>

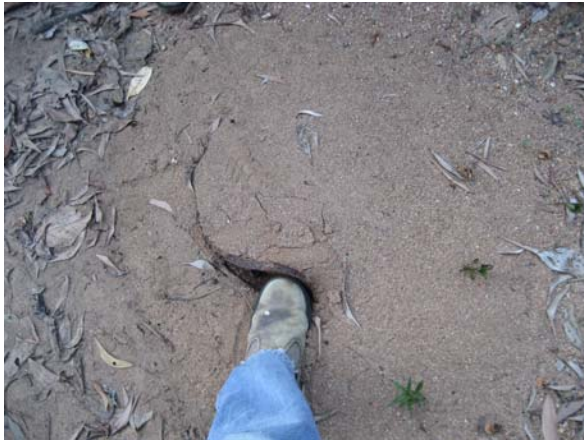
One local example where design features may need to be reconsidered for future crossings is the use of Wetpour safety surface for flooring, previously employed in the Stoney Creek underpass on the Tully-Mission Beach Road. In a culvert that would be subject to regular major flows that would erode a natural surface, Wetpour was presumably utilised to mimic natural ground. When observed in late 2007 by the author it was noted that this surface had, in part, been stripped from the floor and deposited downstream under silt (see Plate 16).

PLATE 16 – Wetpour safety surface having lifted from the culvert floor washed away and covered with silt (photographed late 2007).

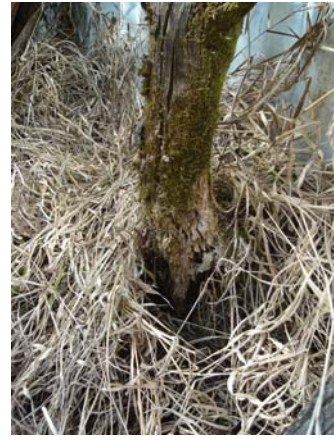
PLATE 17 – Decomposing 'furniture' in the East Evelyn fauna underpass (photograph late 2007).

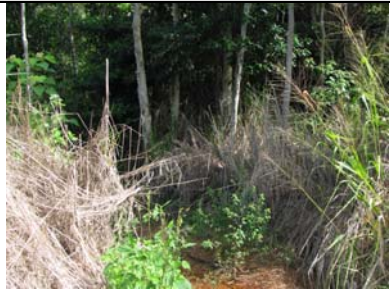
<p>PLATE 18</p>

<p>PLATE 19 – Vegetation upstream of pipe</p>	<p>There is some forest connectivity either side of the road. It is not identified by Biotropica (2008) as a CG within a Habitat Linkage. It is likely the current pipe provides little opportunity for fauna movement. No need for immediate action, however if road upgrades in the future present an opportunity to upgrade, it would be desirable to install a taller (up to 3x3m) culvert with a dry cell passage plus appropriate guide fencing / rehabilitation.</p>
B	To the south of CG6	80km/h speed limit sign indicating change in speed limit from 60km/h. The balance of the road through to El-Arish Mission Beach Road remains at 80km/h.		<p>If signage was moved to the north of CG6 (approximately 350m north of its current location) then speeds in a critical crossing, also identified by Moore and Moore (1999), would be reduced thereby enhancing braking distances.</p> <p>Speed limits would require enforcement.</p>

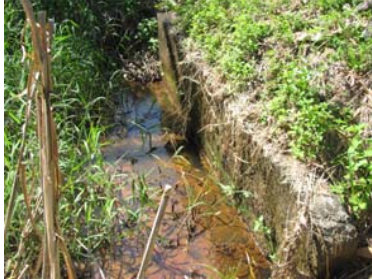
C	CG6	Culvert entirely under water, near a bikeway and underneath power line.

<p>PLATE 20 – Culvert immersed in water</p>

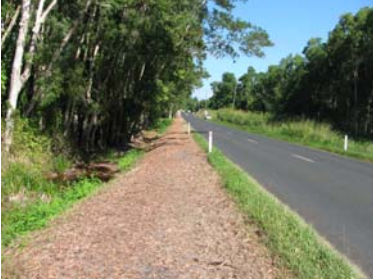
<p>PLATE 21 – The low grade of the road in this location. View southwards along the 'bicycle path'. Note the powerlines on the western side of the road.</p>	Culvert unlikely to support the passage of any terrestrial species. Very little scope to increase culvert diameter without significant raising of the road. Vegetation to the immediate east is comprised of a narrow strip between the road and urban allotments.
D	CG6	A four cell culvert approximately 80cm tall. There is a major drop off to the eastern side. The surrounding downstream area is currently being rehabilitated.

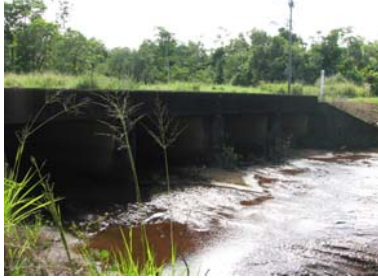
<p>PLATE 22 – Four cell culverts</p>

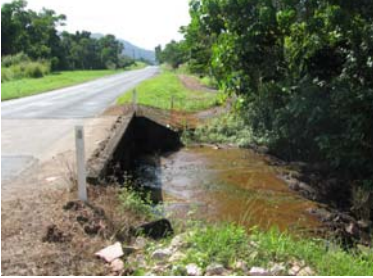
<p>PLATE 23 – Looking northward along the 'bicycle path'. Note the drop to the east of the culvert's concrete apron.</p>	The cells might provide some movement opportunities for small terrestrial species. Given the lower creek profile on the eastern side of the crossing, it would be possible to increase the height of the culvert cells by dropping the upstream creek profile whilst not compromising the current road profile. It appears possible that large ($\geq 3 \times 3$ m) box culverts could be installed in this location that may facilitate the movement of some fauna, not necessarily cassowaries. Tenure and land planning on either side of the culvert secures the long term protection of vegetation in this location.

It is noted during field work that the current 'bikeway' is in state of disrepair and is hazardous in some locations (see Plate 23). Rectification of the path would also need to consider how it interfaces with potential cassowary crossing measures. Integrating cassowary and pedestrian crossings would not be an appropriate outcome based on the Recovery Plan objectives (Latch, 2007) and best practice fauna crossing design (Van der Ree *et al.*, 2007). Where cycling paths cross over underpass structures it would be desirable to construct the path out of a material that allows the permeation of light.

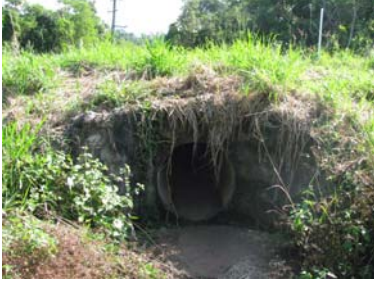
E	In vegetation associated with CG6	80cm diameter pipe

<p>PLATE 24</p>	The pipe drains from the front of vegetated rural residential lots on Mission Circle. Given its dry nature, it is possible that it might provide some passage for small terrestrial fauna. Its value would be enhanced if its diameter were increased; however given the existing profile of the road it is unlikely that a wide culvert could be accommodated without significant rising of the road profile.
F	At the immediate northern edge of vegetation associated with CG6	A road cutting

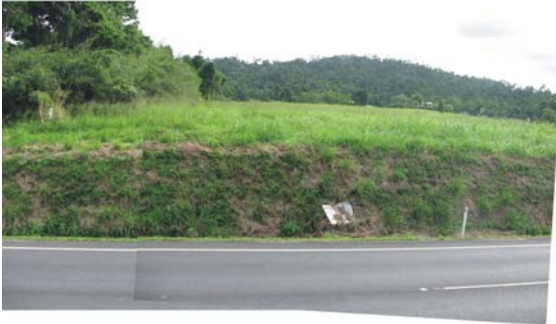
<p>PLATE 25 – Looking westward over the cutting toward the proposed urban subdivision. The vegetation on the left of the photo is at the rear of rural residential properties.</p>	Given the profile of the road, this location would represent a suitable location for a land bridge. However, areas to the west of the road are subject to a proposed urban subdivision and therefore a land bridge is unlikely to be viable in this location.

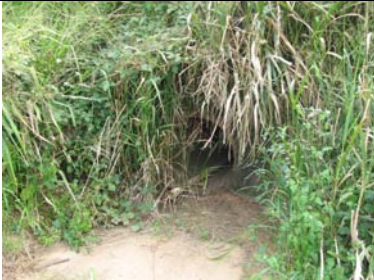
G	To the south of CG5	Pipe with a small diameter

<p>PLATE 26</p>	It is unlikely the culvert would provide reasonable passage for any terrestrial fauna. The proposed urban subdivision at the western edge of the pipe precludes it's viability in future upgrades.

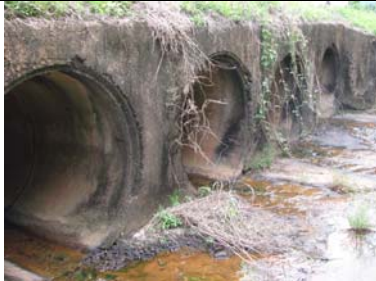
H	CG5	Four cell of pipes 1.2m diameter. There is a major drop off downstream.

PLATE 27 – Eastern outlet of pipes

Elevated road	<p>Elevating the road to the point that would allow cassowaries to pass freely beneath it might be considered at locations H (CG 5) and D (CG 6).</p>	<p>This approach, recommended by both Moore and Goosem (<i>pers comm.</i>, 2008) and adopted as a strategy for the Kuranda Range Road (Environment North, 2004), would allow unencumbered movement by cassowaries and other fauna. Fauna may need to be funnelled to these locations through the use of guide fencing.</p> <p>Although exact design specifications must be considered in consultation with cassowary ecologists, initial indications are that the elevated road should be at least 3m from the existing ground surface (to bottom of road) for a minimum length of 20 metres (shorter distances are too enclosed). The undercarriage of the elevated road structure is likely to require insulation against traffic noise.</p> <p>Bridge costs are approximately \$3,000/m² (<i>pers comm.</i>, Breen, 2008).</p>

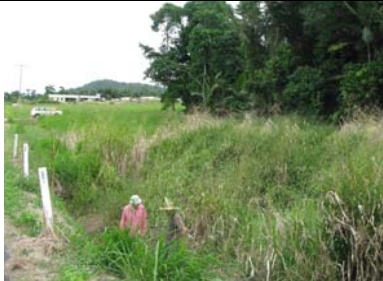
PLATE 28 – Western intake	The existing cells might provide some movement opportunities for small terrestrial species. Given the lower creek profile on the eastern side of the crossing, it would be possible to increase the height of the culvert cells by dropping the upstream creek profile whilst not compromising the current road profile. It appears possible that large ($\geq 3 \times 3 \text{m}$) box culverts could be installed in this location that may facilitate the movement of some fauna, not necessarily cassowaries.
I	To the north of CG5	Nearby pipe approximately 30cm in diameter. The terrain is flat.

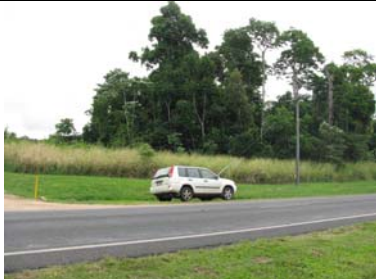
PLATE 29		Although not identified by Biotropica (2008) as a Habitat Linkage or CG, it was identified by Moore and Moore as a crossing point. The pipe is inconsequential to any fauna as most crossings would be made at grade. Some signage as recommended by Moore and Moore (1999) in this location has been installed, however other measures have not. An underpass in this location would require substantial modification of the road grade and a land bridge could potentially affect adjacent existing buildings.

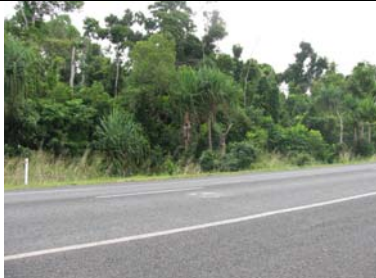
J	To the south of CG5	Inaccessible pipe of small (approximately less than 1m diameter). Wet at the time of investigation.

PLATE 30		As above.

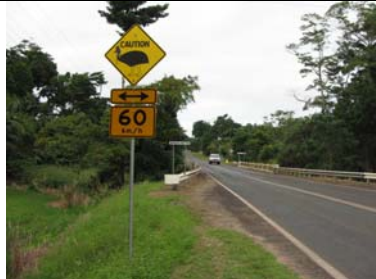
K	CG1	Advisory speed limit sign (60km/h in an 80km/h zone) to the immediate west of the Wongaling Creek crossing. Overhead powerlines.

PLATE 31		It would be favourable if this area were 50km/h. There are overhead wires/cables at the Wongaling Creek crossing (CG1). Consequently a wide swathe below the wires is cleared of native vegetation and overrun by Guinea grass. If the wires/cables were undergrounded or bundled, the area could be revegetated to enhance habitat connectivity.
L	CG1	Crossing of Wongaling Creek.

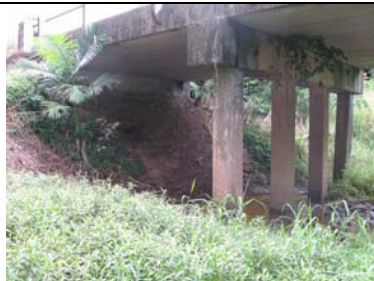
PLATE 32 – West bank.

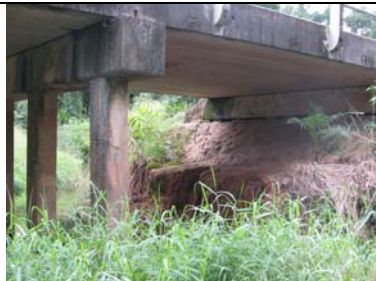
PLATE 33 – East bank of Wongaling Creek.	The rank exotic grass plus the steep unvegetated grades of the Wongaling Creek crossing severely limits its value to cassowaries. Enhancement similar to those at the Tully Mission Beach Road crossing of the North Hull River would be achievable in this location.
M	To the east of CG1	Crossing at grade.

<p>Recontour banks and revegetate to facilitate cassowary movement along Wongaling Creek</p>	<p>This is specific to Location L (covering CG1) at the crossing of Wongaling Creek by El Arish - Mission Beach Road.</p> <p>Rank exotic grass will need to be removed and replaced with appropriate vegetation that would not interfere with QDMR frangibility concerns.</p> <p>One or both banks should be recontoured and landscaped to allow for graded passage under the bridge.</p>	<p>This can be undertaken with relatively little expense. This has been undertaken at the crossing of the North Hull River by the Tully-Mission Beach Road for approximately \$3,500 (see Appendix B).</p> <p>It would be necessary to ensure that recontouring and landscaping will not affect the hydrology of the creek and that downstream areas were unaffected.</p> <p>Preferably this would need to be associated with appropriate guide fencing to maximise utilisation by cassowaries.</p> <p>Considering the importance of this crossing, consideration should be given to removing fill on the approaches to the bridge and significantly lengthening the span of the bridge so that cassowaries have more than just a narrow dry ledge, but also vegetated areas that provide continuity of habitat.</p> <p>The application of aerial bundle cabling or undergrounding of powerlines in this area will allow for the establishment of more effective revegetation which would otherwise be constrained by the existing lines.</p>

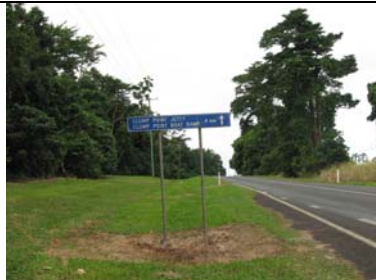
PLATE 34 – Level crossing. Note the broad well maintained clear zone on the northern edge of El-Arish Mission Beach Road.		Although not identified by Biotropica (2008) or Moore and Moore (1999) as a Habitat Linkage/ Connectivity Gap or Crossing Point respectively, there has been cassowary activity/crossings in this area (See Figure 2). Little opportunity exists for underpass or land bridges in this location, however there are opportunities for traffic management.

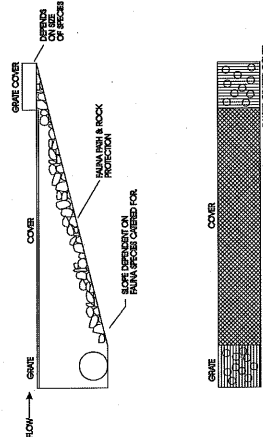
H. GRATED INLET FAUNA PATH DROP STRUCTURE
